PREPARED FOR: Transport Scotland
COPY TO: Historic Scotland
PREPARED BY: Gareth Talbot
DATE: 05 June 2015
PROJECT: 495298 - A9 Dualling – Glen Garry to Dalraddy
TITLE: Cultural Heritage Technical Note [01] – Flood defence earthworks at Ruthven Barracks.
Historic map analysis to help determine whether earthworks are contemporaneous with the Barracks.
DOCUMENT REF: A9P09-CFJ-EHR-X-ZZZZZ_XX-TN-EN-0001
STATUS: Issue Suitability: S04 Version: P01

1.0 Purpose of this Technical Note

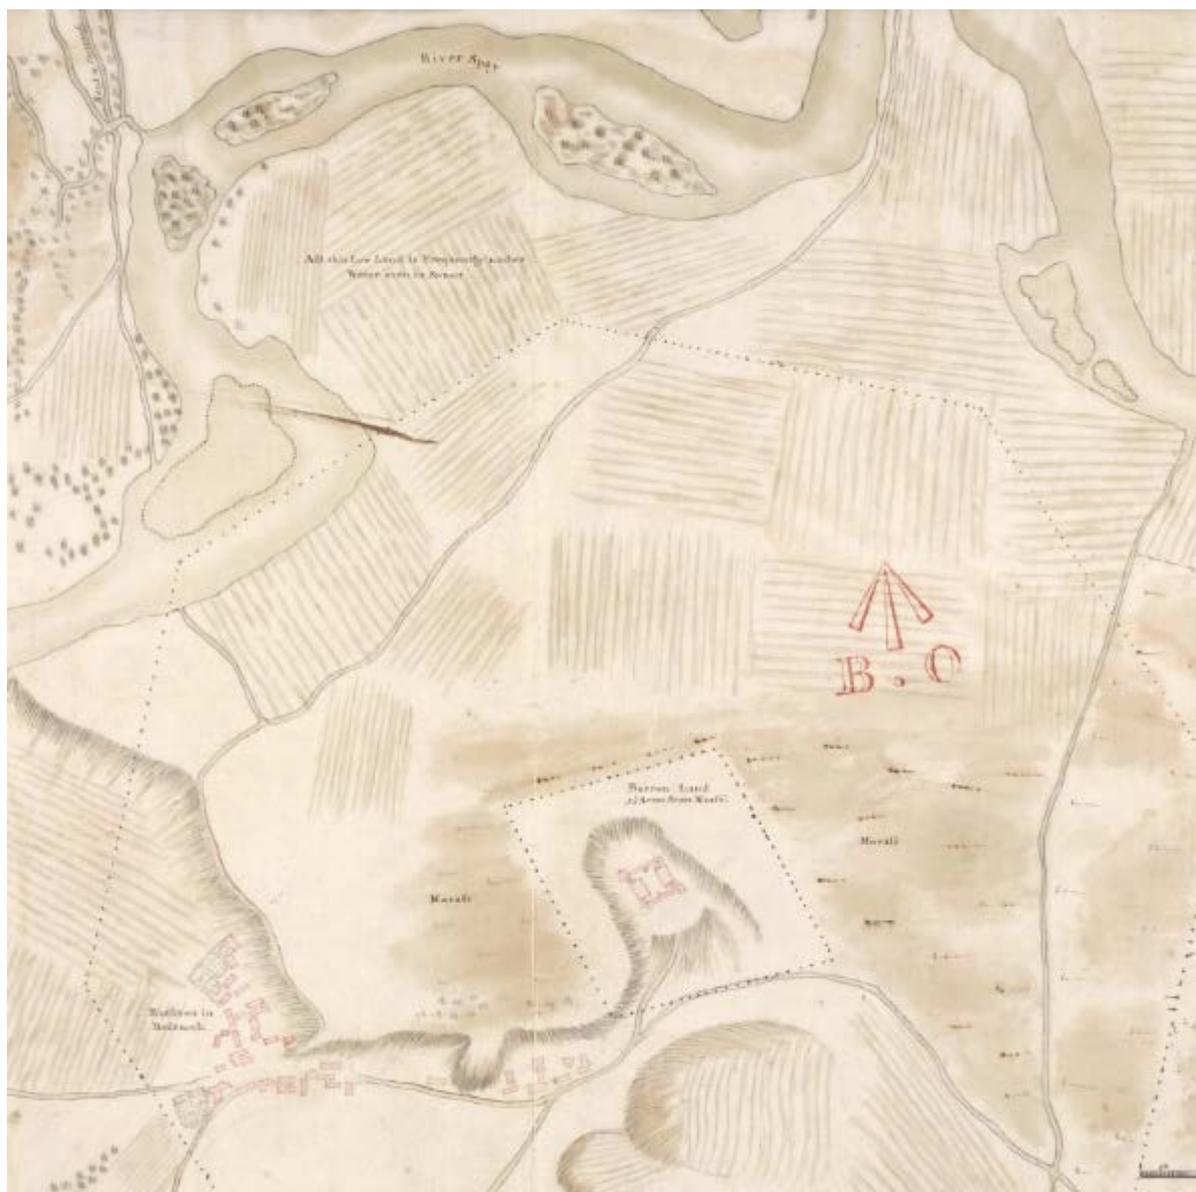
Andrews Jelfe, 1719: A Plan of the Barrack of Ruthven in Badenoch

Andrews Jelfe's map of 1719 shows the barracks, with associated earthworks extending to the west and north which were likely in place to protect the western approach to the barracks. There is no evidence of the earthwork banks that form the present-day flood defences.

The land surrounding the barracks appears to have been set aside for crops, note the rig and furrow markings, and is also described as being under water, even in summer, suggesting that there were no flood defences in place.

The map dates to 1719, and as the barracks were not complete until 1721, it is possible that flood defence earthworks were constructed after 1719. The map does demonstrate that the flood defences did not form part of the original barrack complex.

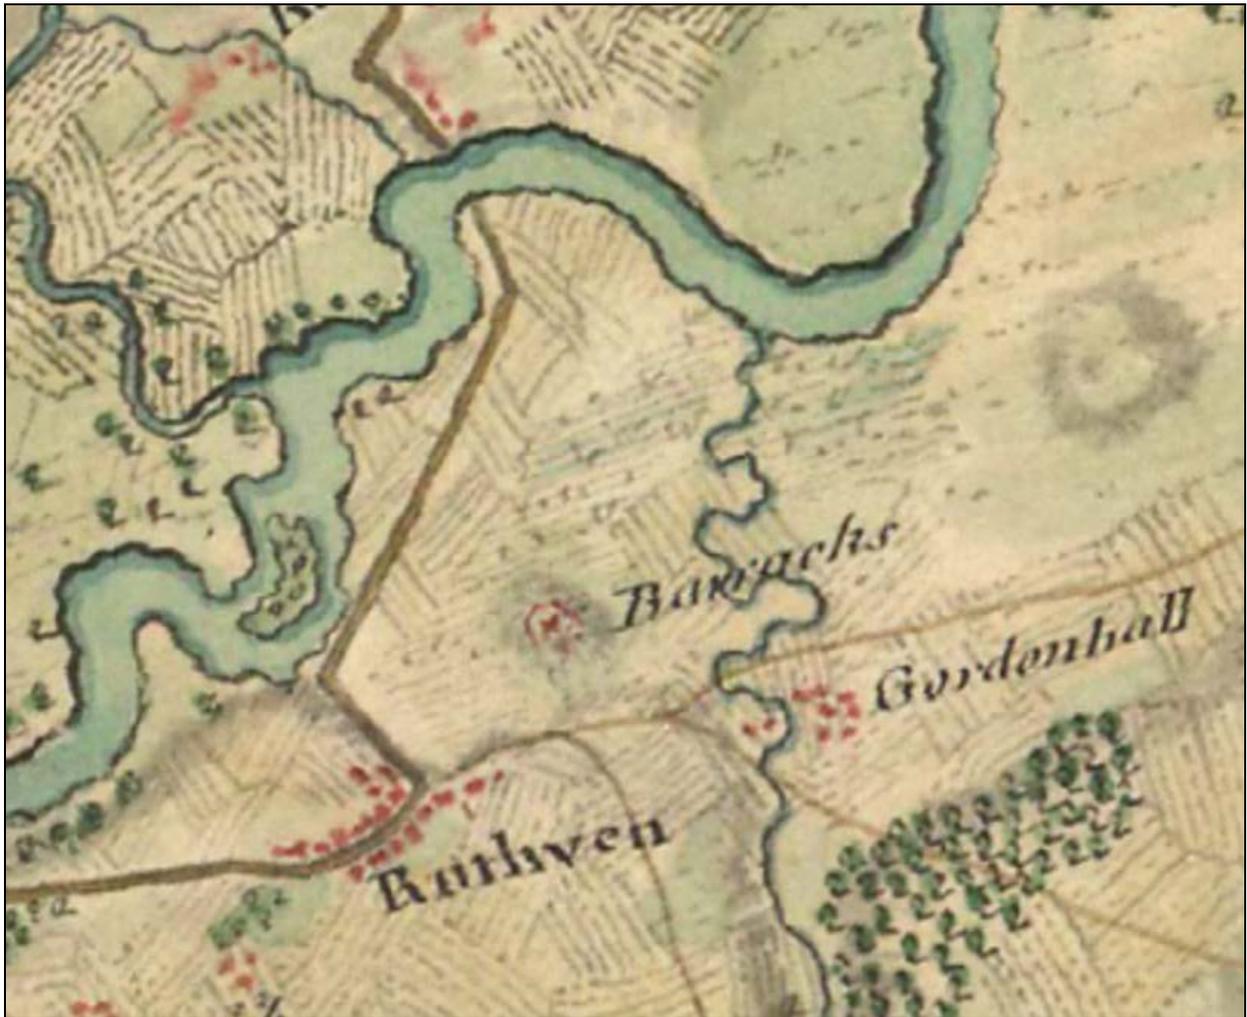
Roy Highlands 1747-52: flood defences are not shown, although the scale of the map is likely to have meant that small earthworks would not have been included.

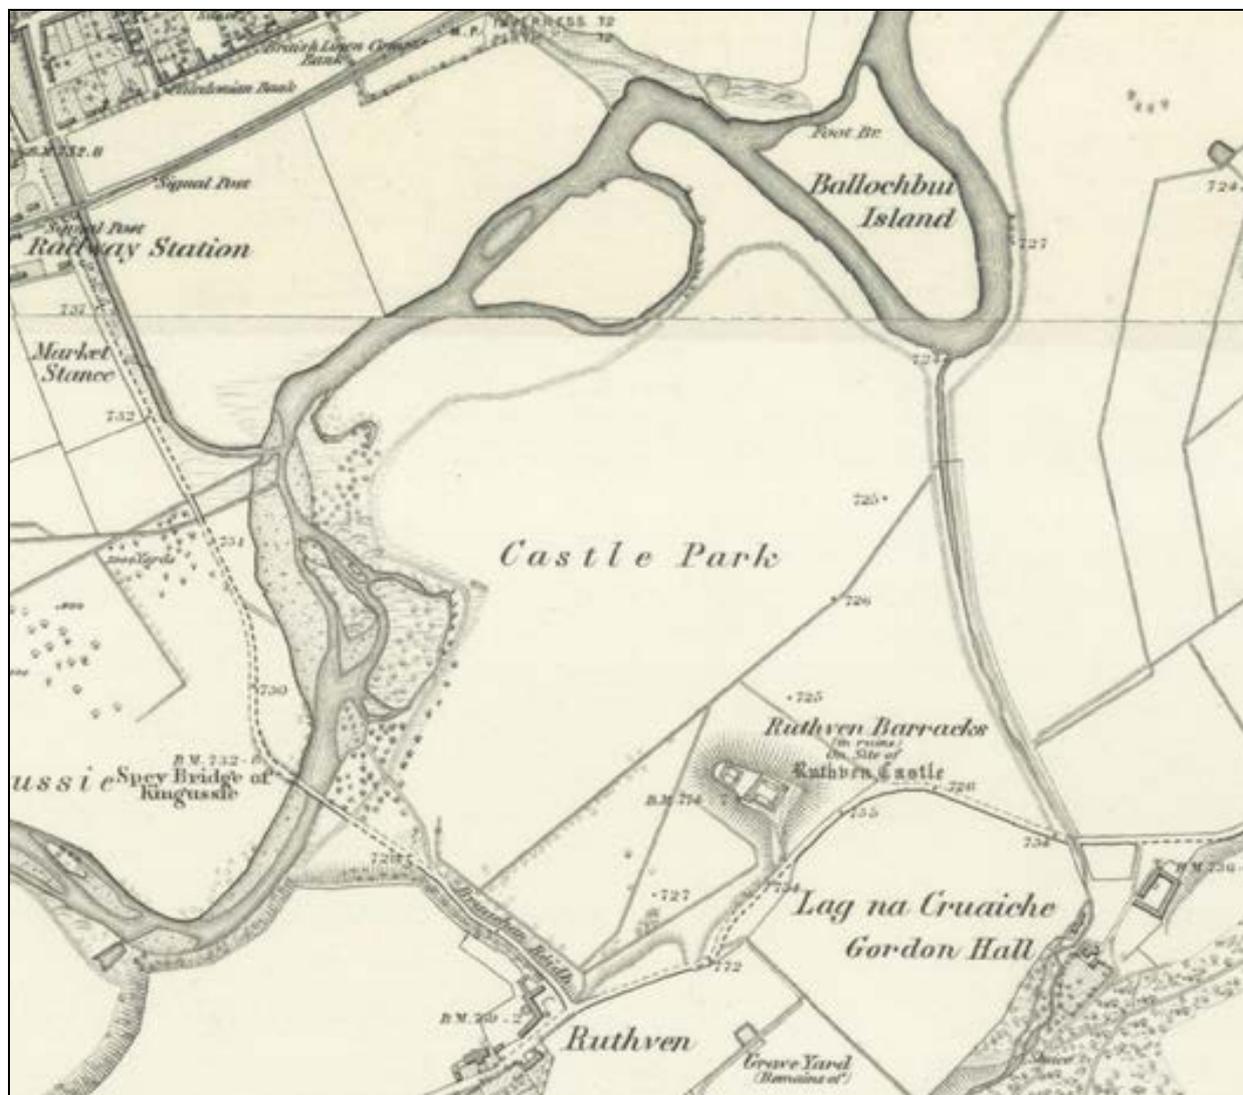
OS 6" 1843-1882: the flood defence earthworks are now in place. It is likely that they have been in place since at least 1843. Kingussie Railway station is shown at the north-west of the map, and as this was constructed in 1863 this indicates that it is possible the earthworks post-date 1843.

The earthworks that are contemporaneous with Ruthven Barracks (as shown on Jelfe's 1719 map) are still in place, with the more recent flood defence earthworks linking to them just to the south of *Spey Bridge of Kingussie*.

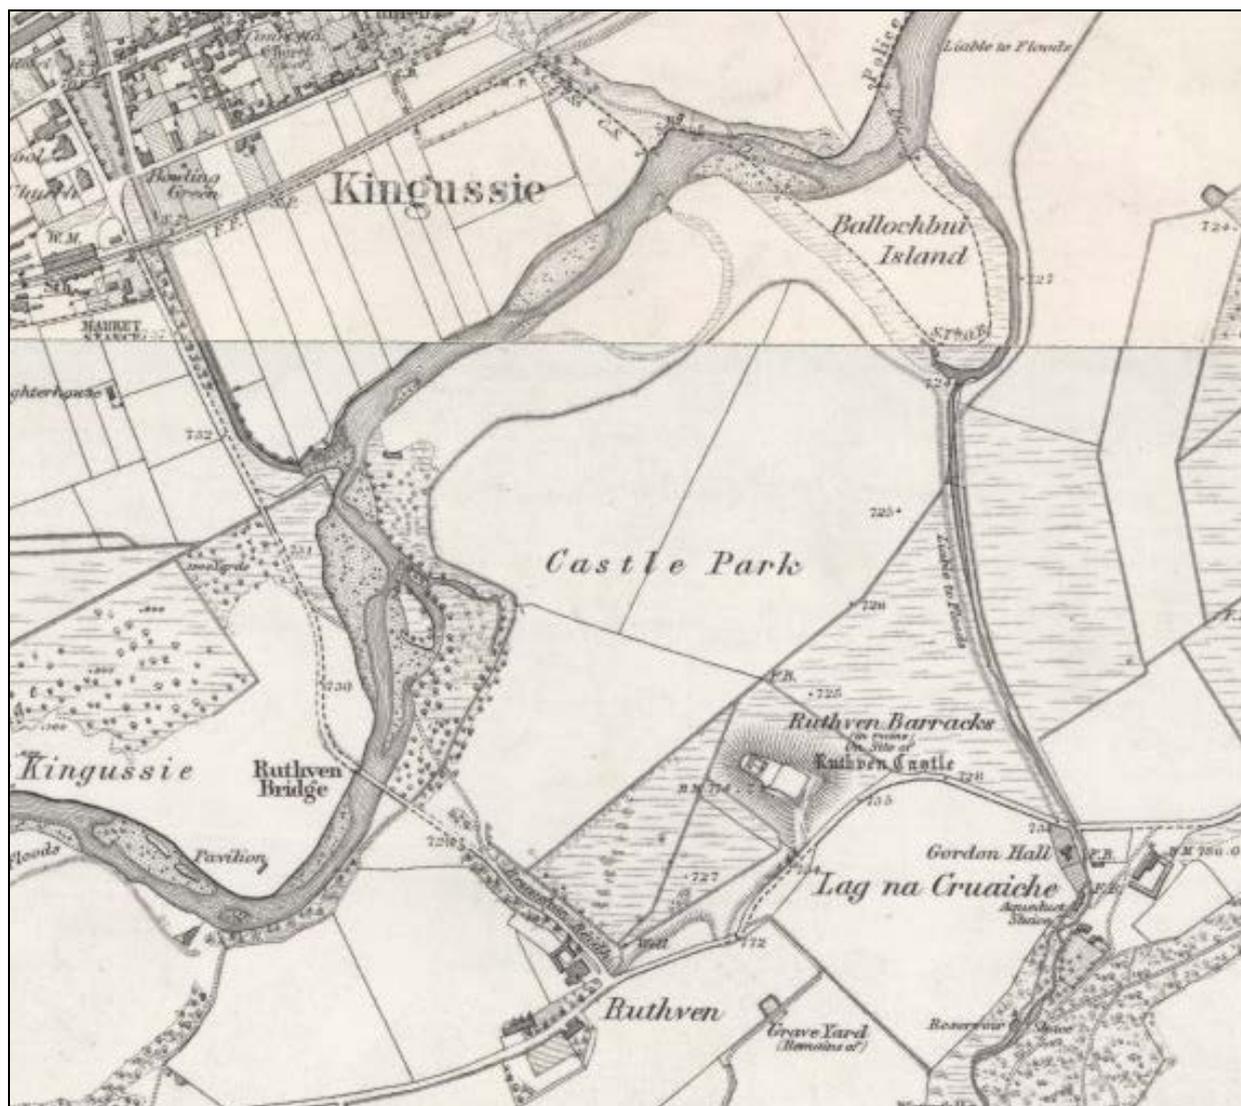
OS 6" 1888 – 1913: defences are still in place, and have not altered since the last OS 6 inch map.
